INDOOR AIR QUALITY ASSESSMENT

**Woods Memorial Library
19 Pleasant Street
Barre, Massachusetts**

Prepared by:
Massachusetts Department of Public Health
Center for Environmental Health
Emergency Response/Indoor Air Quality Program
January 2006

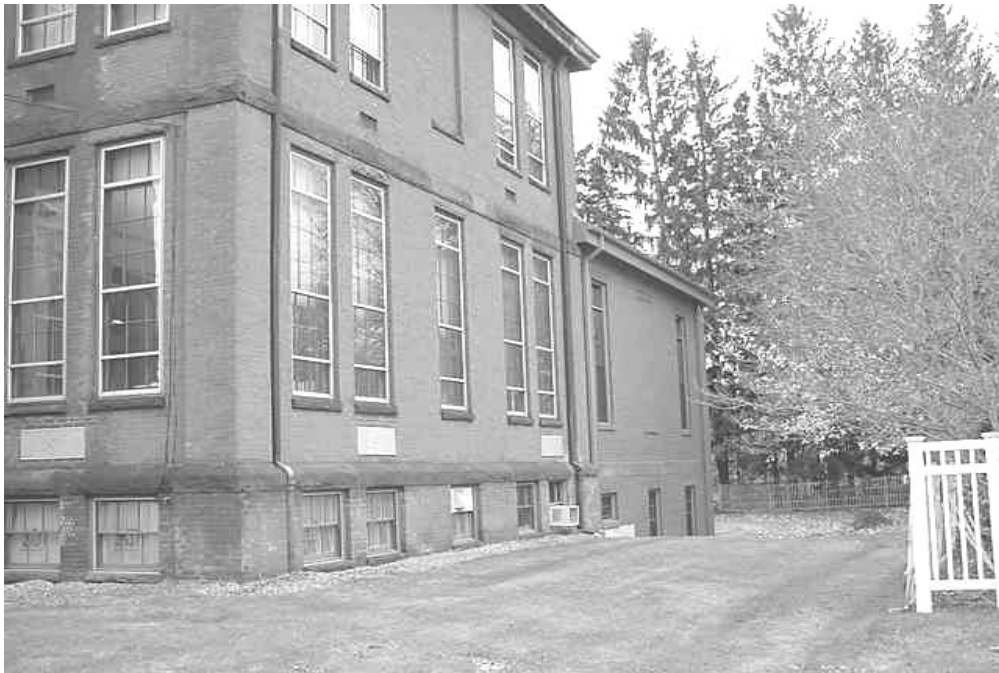
Picture 1

Woods Memorial Library (Original Building Left Foreground), New Wing (Background)

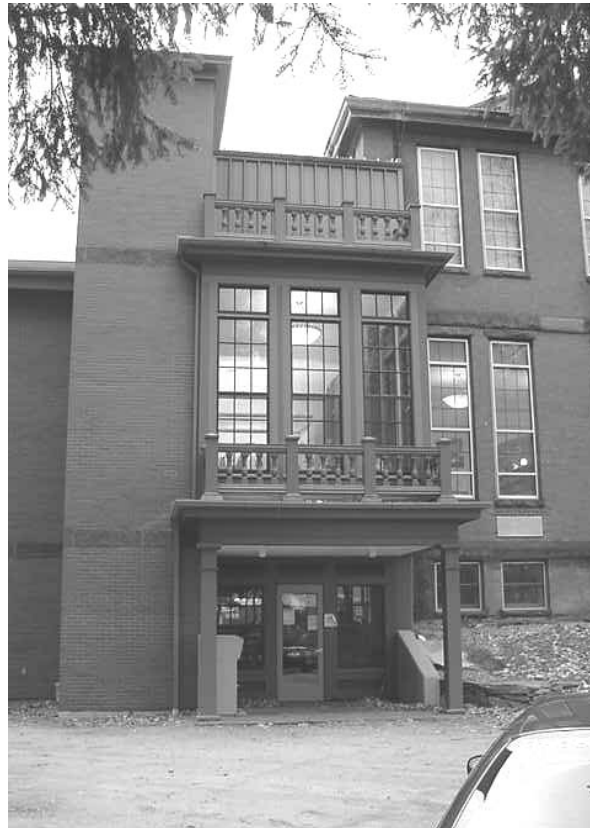
Picture 2

Woods Memorial Library, New Wing, Basement Entrance

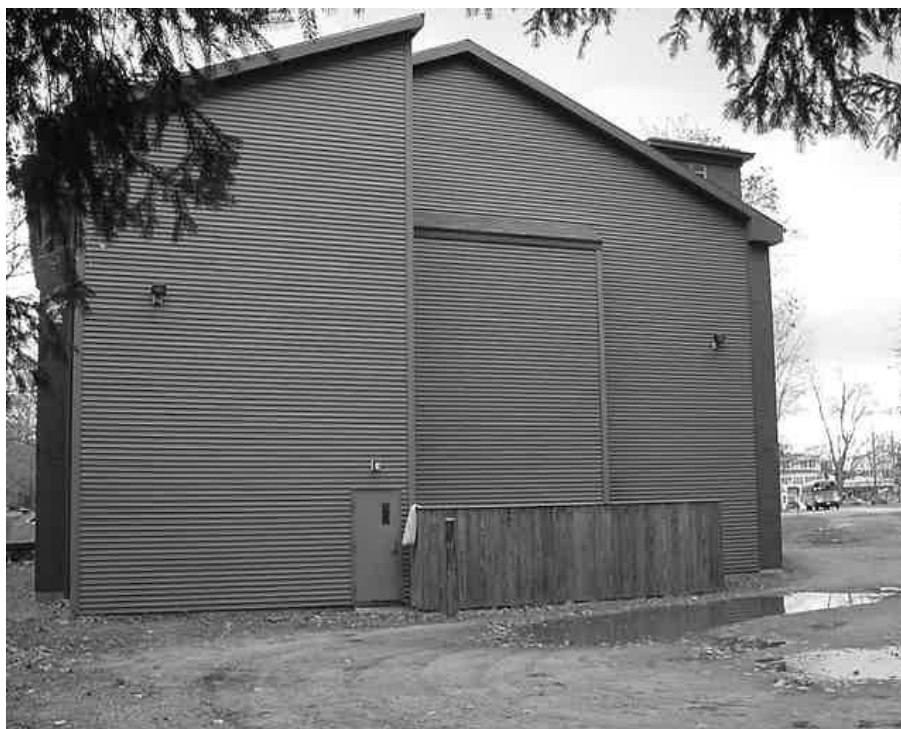
Picture 3

Woods Memorial Library, New Wing, Rear of Building

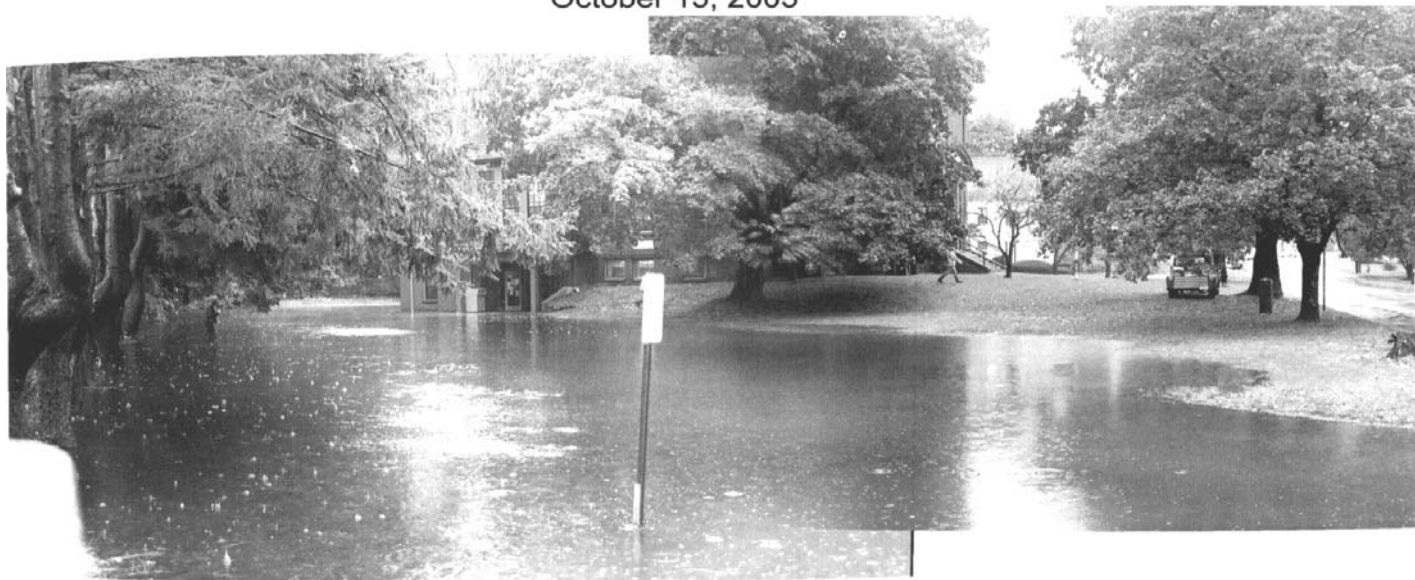
Picture 4

The water damage to the library resulted from a rainstorm that delivered an estimated 2.6 inches of rain on the weekend of October 15, 2005 (Weather Underground, 2005). The rainstorm resulted in flooding reports throughout Massachusetts. The flooding and clean up efforts were documented by L. Allen of the WML (Pictures 4 through 8).

**Flood at Woods Memorial Library, Barre, Massachusetts
October 15, 2005**

(Taken By L. Allen of the WML)

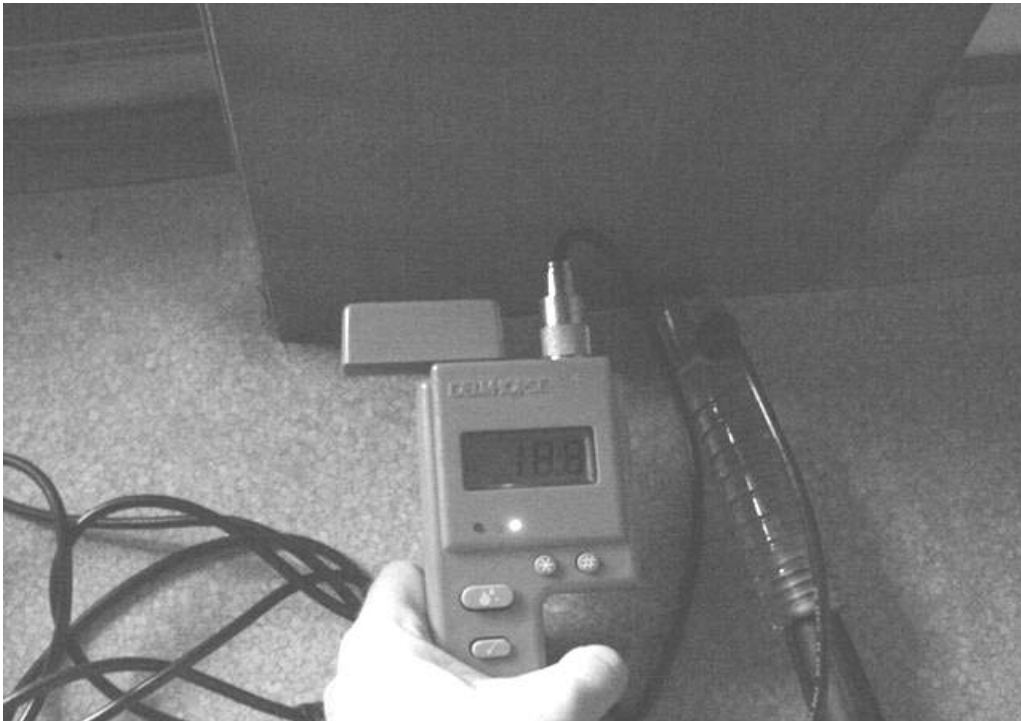
Picture 10

In an effort to ascertain moisture content of gypsum wallboard (GW), carpeting and wood a Delmhorst probe was inserted into the surface of GW (Picture 10), carpet and wood. The Delmhorst probe is set to sound a signal when a moisture reading of ≥ 0.5 percent in GW or ≥ 15 in wood is detected.

Delmhorst Probe Was Inserted Into Building Wood

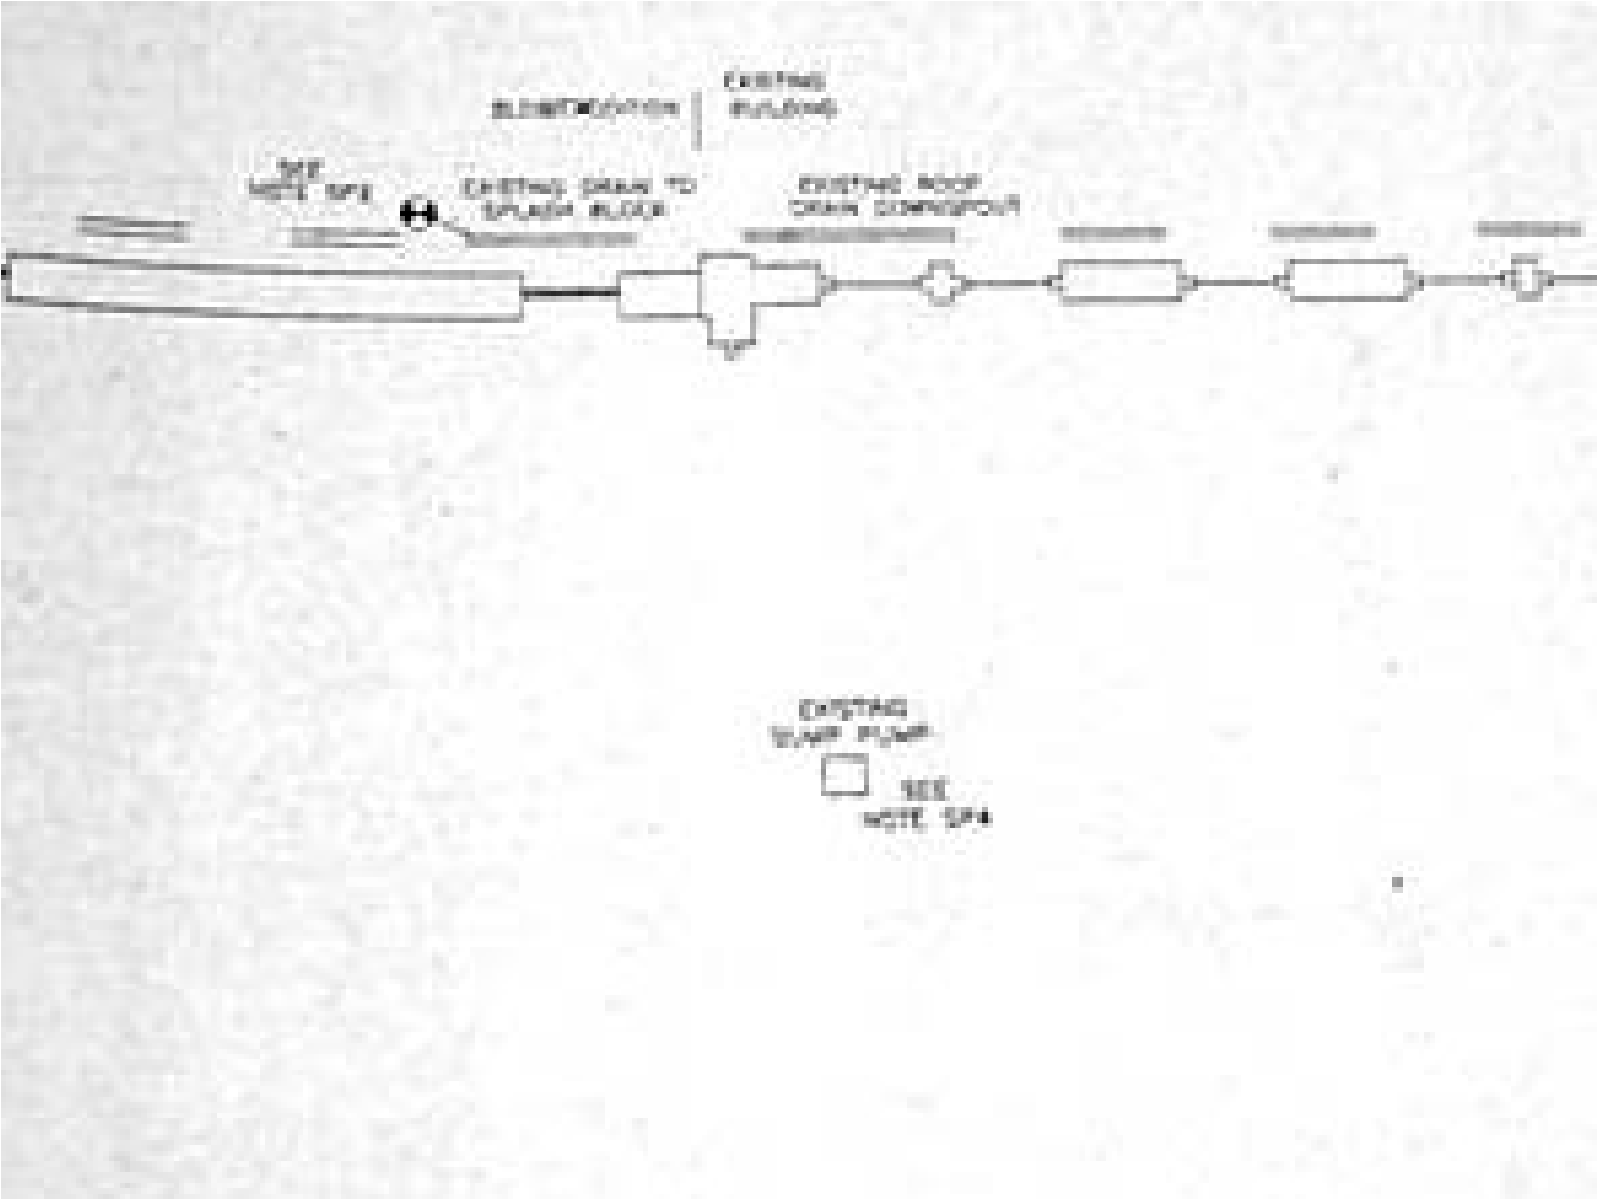
Blueprint 3

(Figure 2, Blueprint 3). Behind the curtain wall is an air space that allows for water to drain downward and for the exterior cladding system to dry. At the base of the curtain wall should be weep holes that allow for water drainage. Opposite the exterior wall and across the air space is a continuous, water-resistant material adhered to the back up wall that forms the drainage plane.

Renovation Blueprint, Denoting Sump Pump Installed In the Existing Floor of WML
